UNDERWATER BRIDGE INSPECTION REPORT

STRUCTURE NO. L5733
ABANDONED RAILROAD
OVER THE
MISSISSIPPI RIVER
DISTRICT 5 - HENNEPIN COUNTY

JOB NO. 3512

MINNESOTA DEPARTMENT OF TRANSPORTATION
UNDERWATER BRIDGE INSPECTION

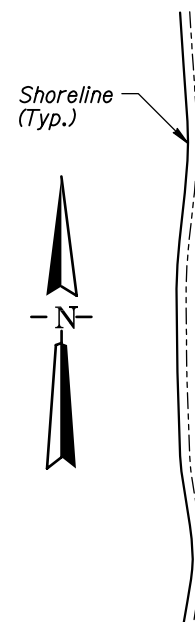
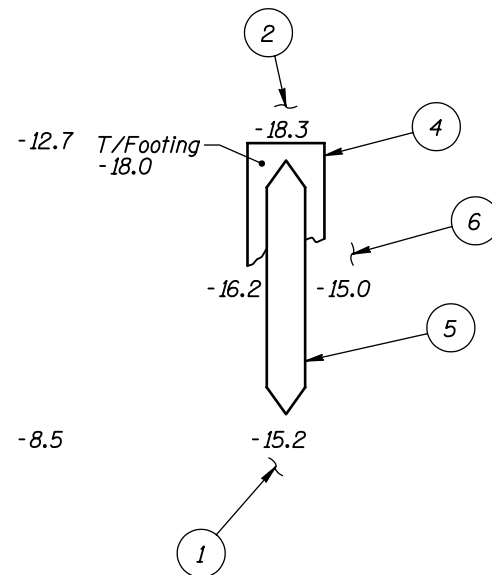
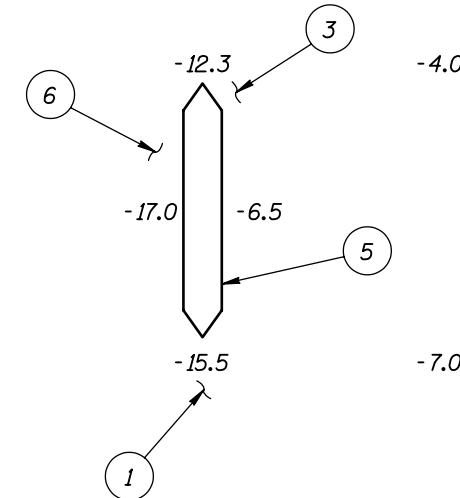
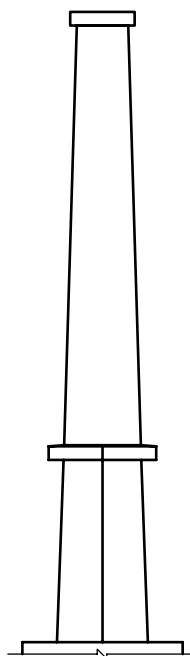
INSPECTION AND SOUNDING PLAN

- 1 The channel bottom consisted of sand infilling at the downstream end of both piers with up to 1 foot of probe rod penetration.
- 2 The channel bottom consisted of riprap from 1 to 2 feet in diameter at the upstream nose and 6 to 8 inch diameter riprap along both sides of the West Pier.
- 3 The channel bottom consisted of riprap from 1 to 4 feet in diameter at the upstream nose and 6 to 8 inch riprap along both sides of the East Pier.
- 4 The top of the footing was exposed from the midpoint along the west face, around the upstream nose, and to the upstream quarter point along the east face with 4 inches of vertical face detected at the upstream end.
- 5 The stone masonry was in good condition with minor hairline cracks observed in the joints at random locations.
- 6 A light accumulation of steel debris was observed scattered on the channel bottom around both piers.

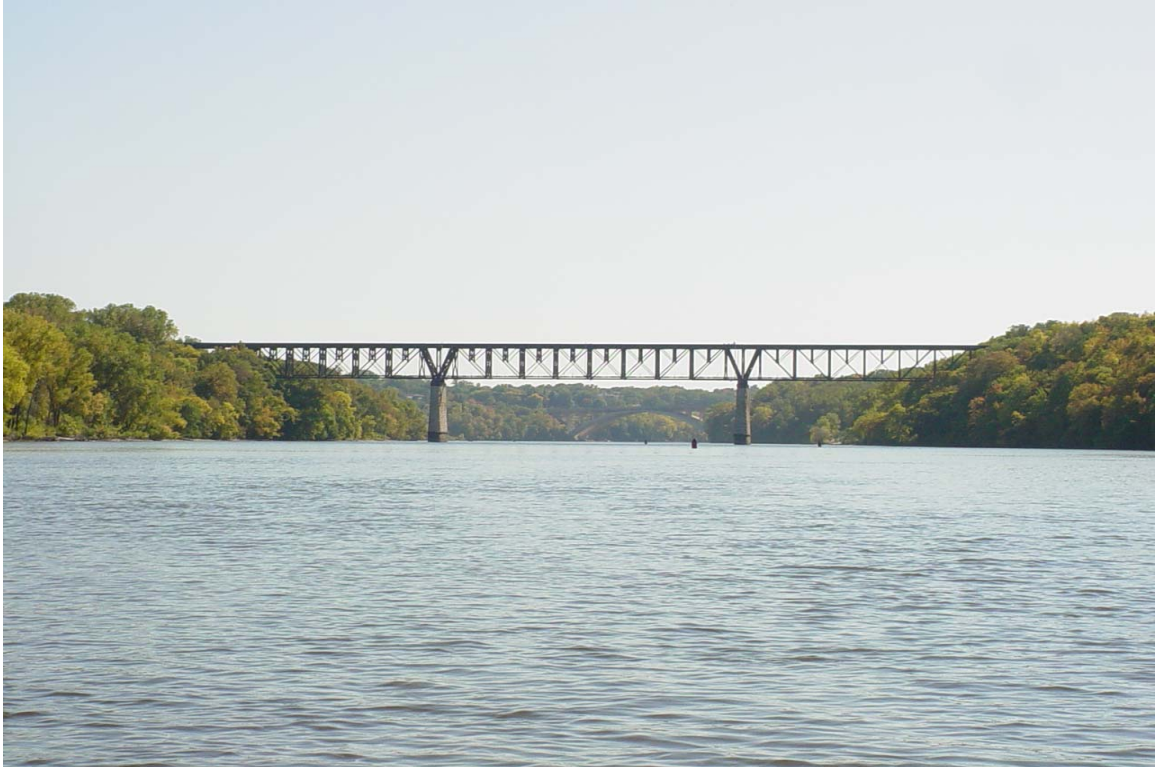
Photograph 1. Overall View of the Structure, Looking South.

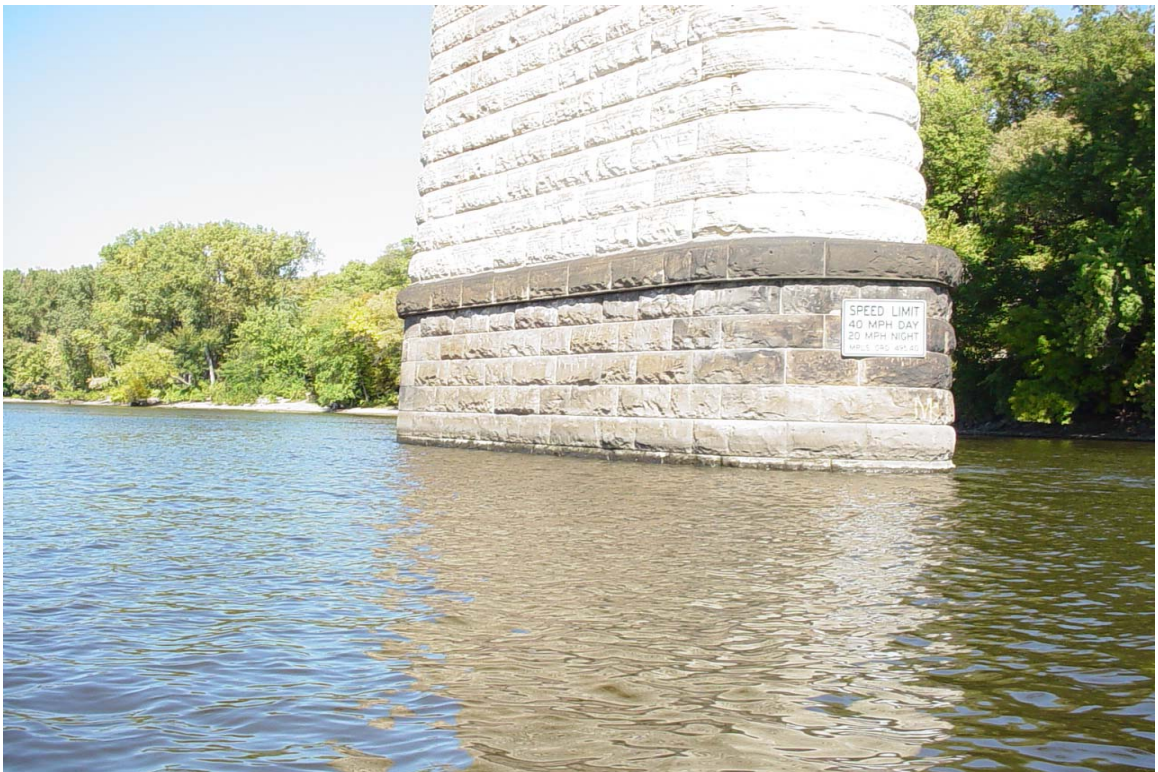
Photograph 2. View of East Pier, Looking Northeast.

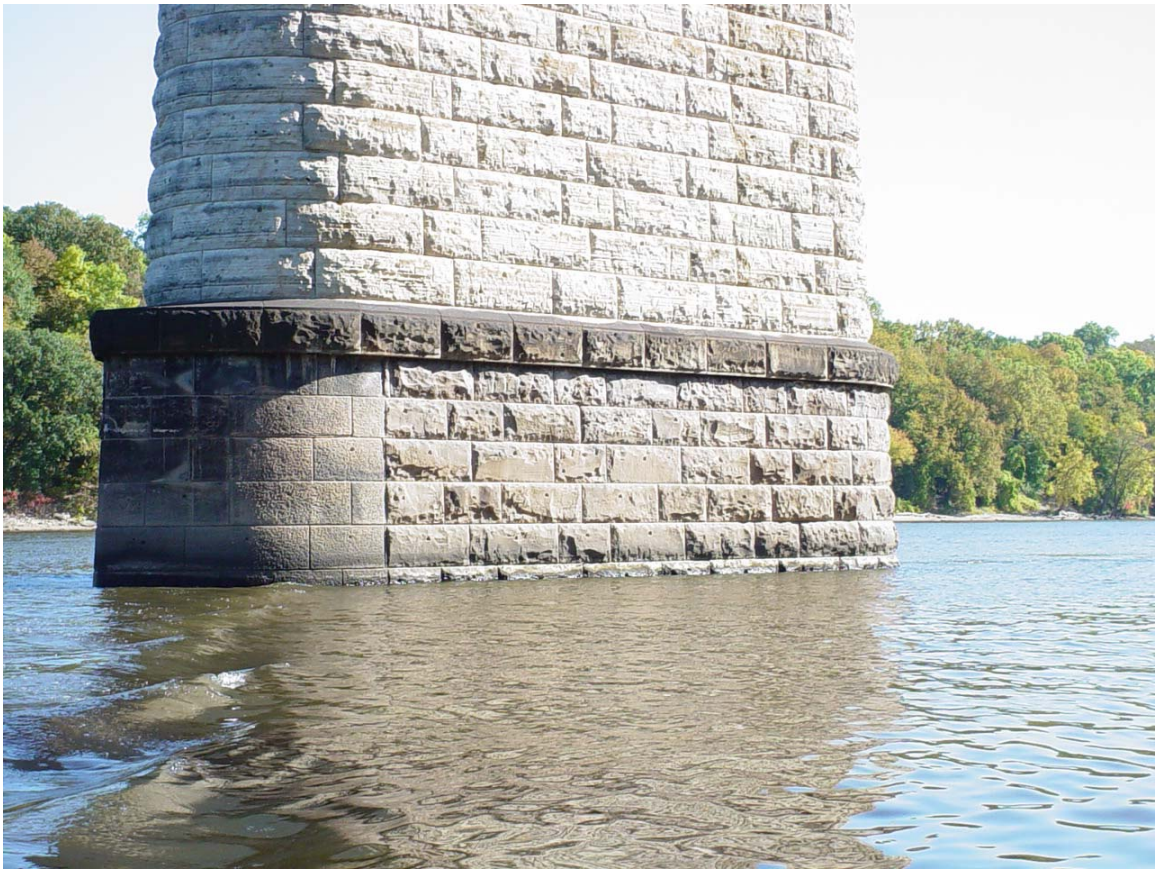
Photograph 3. View of West Pier, Looking Southeast.
